# **FIRE PERFORMANCE OF EXTERIOR CLADDINGS**

FCRC Project 2 B-2  
FIRE PERFORMANCE OF MATERIALS

Fire Code Research Reform Program  
April 2000

C.A. Wade and J.C. Clampett

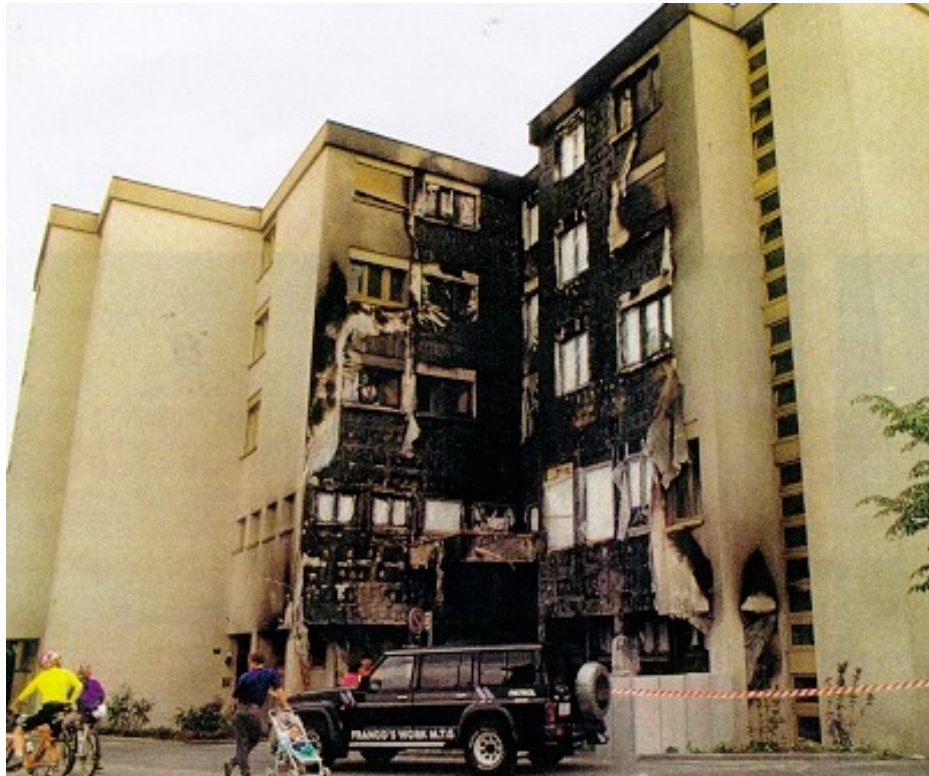
**Figure 1: Apartment building, Munich** (source: Mayr, 1996)

A five-level apartment building with a façade made of a composite thermal insulation (about 100 mm thick) comprising polystyrene and foam plastics slabs and a reinforced covering layer. A rubbish container fire on the exterior ignited the cladding and created extensive damage. Windows were broken and flames spread into rooms at upper levels (Mayr, 1996).

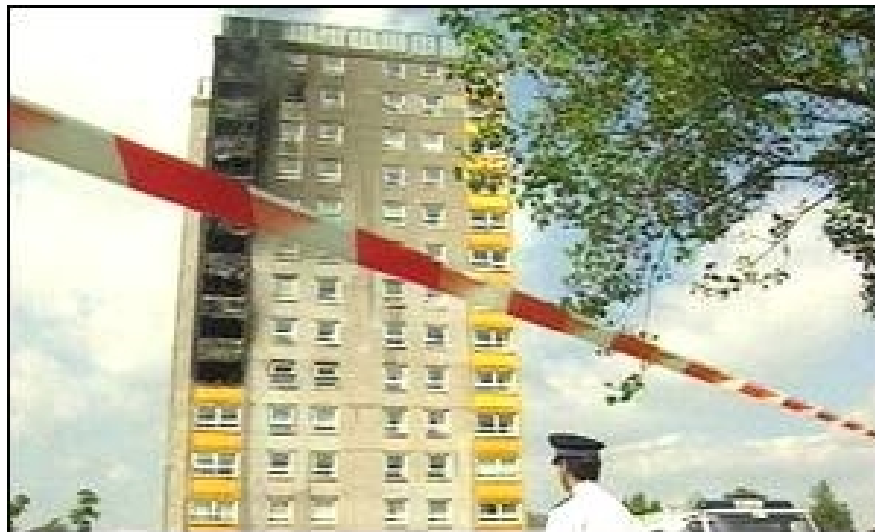
**Figure 2: Apartment building fire, Irvine, Scotland** (source: BBC Online Network, 1999)

The fire, which started in a flat on the fifth floor of a 13-storey apartment block, broke out through the window and quickly spread vertically up the exterior face of the building engulfing the upper nine floors within minutes. The building was of concrete construction but had full height composite window units comprising a GRP panel below the window and PVC window frames. The fire ignited the GRP panels and spread vertically. There was one death in the incident and that was in the apartment of origin (anon, 1999a; anon, 1999b). Therefore the combustible window components were unlikely to have contributed to the death.

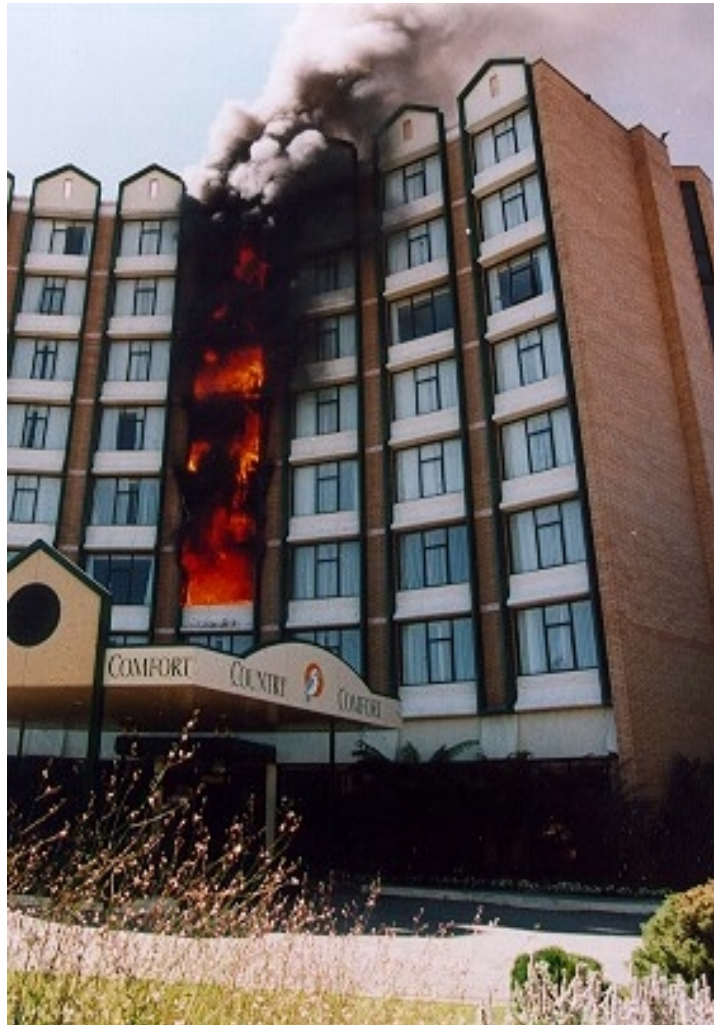
**Figure 3: Motel fire, NSW, Australia** (source: NSWFB, 1999)

This was an eight-storey accommodation building generally of concrete/masonry construction but with fibreglass panels beneath the windows. A fire occurred at the third-floor level and following breakout through the window, flames rapidly spread to the top of the building via the fibreglass panels positioned vertically above the fire source. Fire penetrated into the third- and fourth-floor levels. There were no deaths associated with the vertical spread of fire (NSWFB, 1999).

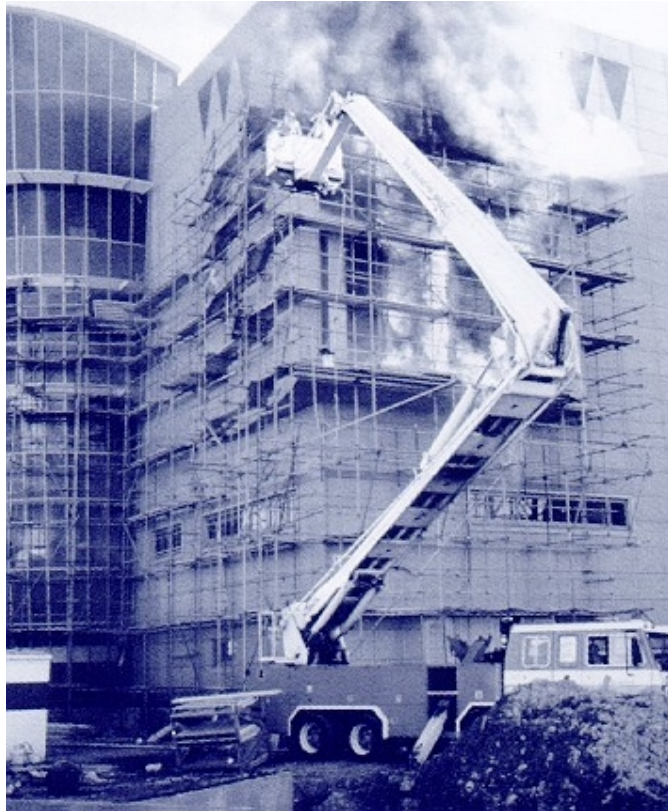
**Figure 4: Museum construction fire, Wellington** (source: NZFS, 1997)

This was a large multi-level national museum building under construction. The exterior cladding used comprised a thin aluminium-faced panel with a polyethylene core, mounted over extruded foam polystyrene insulation board and building paper. A worker, heat welding a roofing membrane, ignited the building paper and this quickly spread up the exterior façade involving the polystyrene and cladding panel. There were no deaths or injuries associated with the fire.

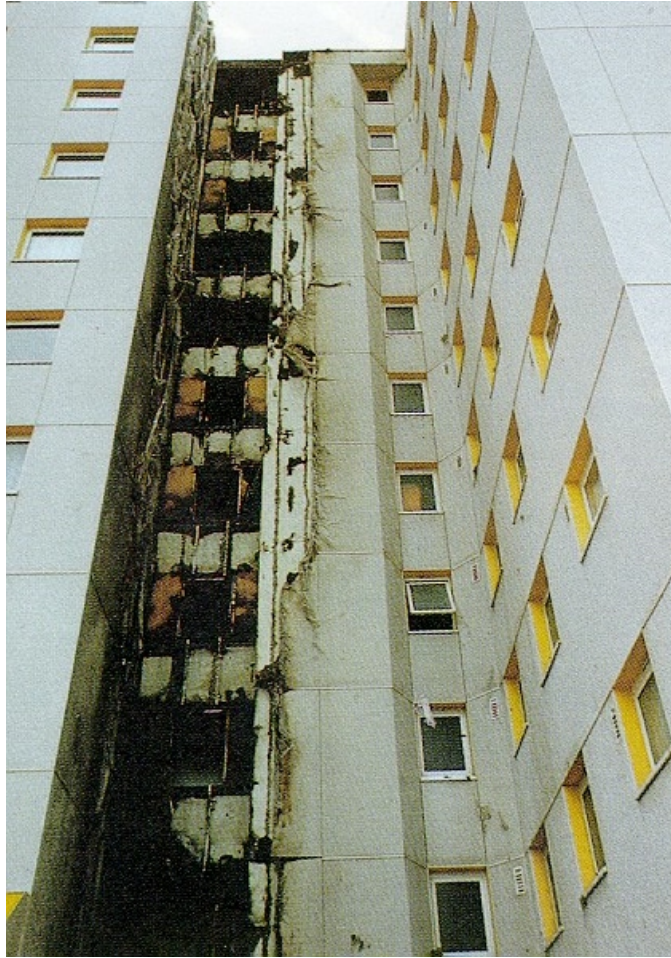
**Figure 5: Knowsley Heights fire** (source: anon, 1992)

This was an 11-floor apartment tower block. A deliberately lit fire, in the rubbish compound outside the building, spread up through a 90 mm gap between the tower's rubberised paint-covered concrete outer wall and a recently installed rain screen cladding. The rapid spread of fire was thought to have been caused by the lack of fire barriers in the cavity gap passing all 11 floors and providing a flue for hot gases to rise. (anon, 1993). The fire destroyed the rubbish compound and severely damaged the ground floor lobby and the outer walls and windows of all the upper floors. No smoke or fire penetrated into the flats and the building was reoccupied by tenants later the same day (anon, 1992). The rain screen material was a Class O (limited combustibility) rated product using BS 476 parts 6 and 7 (BSI, 1981; BSI, 1987). Building regulations were changed as a result of this fire.

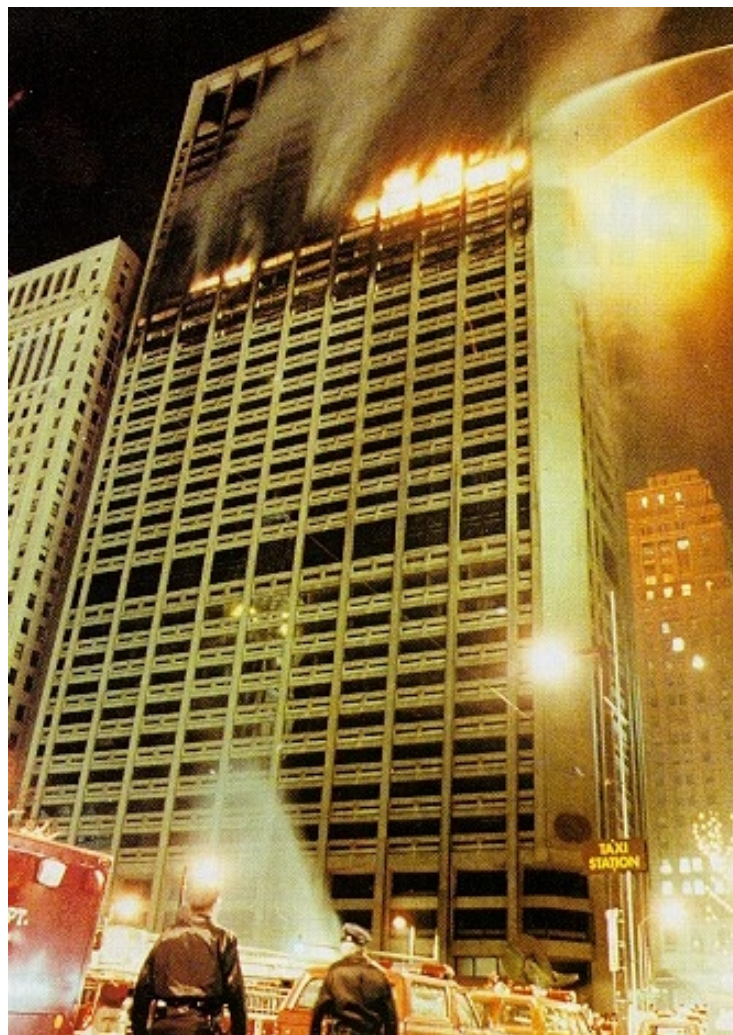
**Figure 6: One Meridian Plaza fire** (source: Klem, 1991)

This was a fire which occurred on the 22<sup>nd</sup> floor of a 38-storey bank building. The building frame was structural steel with concrete floors poured over metal decks and protected with spray-on fireproofing materials. The exterior of the building was covered by granite curtain wall panels with glass windows attached to perimeter floor girders and spandrels. At the time of construction only the below ground service floors were fitted with sprinklers and since then they had been added to the 30<sup>th</sup>, 31<sup>st</sup>, 34<sup>th</sup>, and 35<sup>th</sup> floors and parts of floors 11 and 15. Fire broke through windows on the 22<sup>nd</sup> floor and the heat exposure from the window plumes ignited items on the floor above. The fire was stopped when it reached the 30<sup>th</sup> floor which was sprinklered (FEMA, 1991b, Klem 1991).

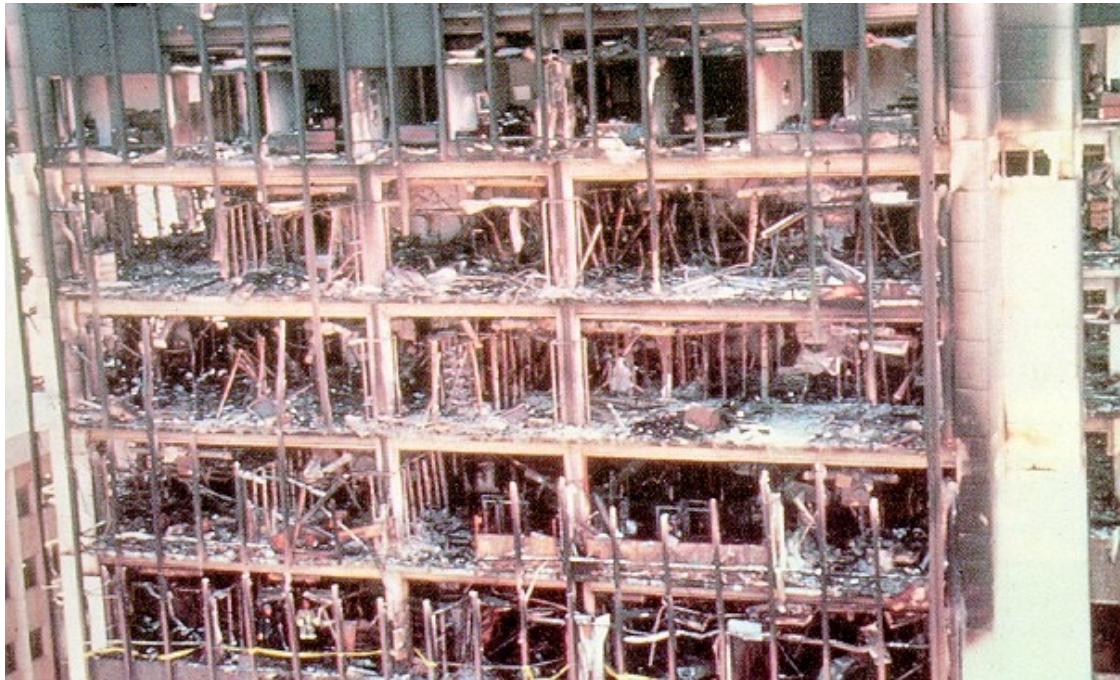
**Figure 7: First Interstate Bank fire** (source: Morris, 1990)

The bank was a 62-storey tower with sprinkler protection only in the basement, garage and underground pedestrian tunnel. An automatic sprinkler system was being installed in the building at the time. The building had a structural steel frame with spray-on fire proofing with steel floor pans and lightweight concrete decking. The exterior curtain walls were glass and aluminium with a 100 mm gap between the curtain wall and the

floor slab, where the fire stopping, comprised 15 mm gypsum board and fibreglass caulking. The fire started on the 12<sup>th</sup> floor and extended to the floors above primarily via the outer walls of the building. Flames also penetrated behind the spandrel panels around the ends of the floor slab where there was sufficient deformation of the aluminium mullions to weaken the fire stopping, allowing the flame to pass through even before the windows and mullions had failed. The flames were estimated to be lapping 9 m up the face of the building and the curtain walls including windows, spandrel panels, and mullions, were almost completely destroyed by fire. The upward extension stopped at the 26<sup>th</sup> floor level (FEMA, 1988; Chapman, 1988; Klem, 1989; Morris, 1990).

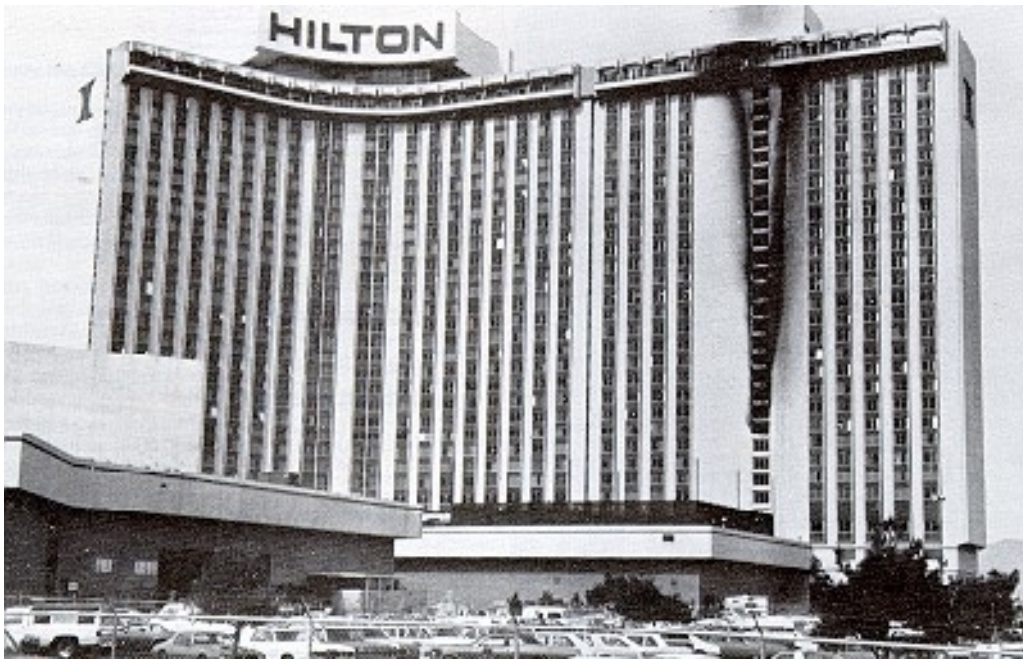
**Figure 8: Hilton Hotel fire** (source: anon, 1982)

- Flames outside the upper windows radiated heat through the windows and ignited curtains, timber benches with polyurethane foam padding, which then ignited carpeting on room surfaces.
- Flames contacted the plate glass windows. It is believed that the triangular shape of the spandrels, and recessed plate glass caused additional turbulence which rolled the flames onto the windows resulting in early failure.

There were eight deaths in this fire. Three were in the eighth floor lift lobby, one by jumping/falling from the 12<sup>th</sup> floor, and four in hotel rooms in the east tower. The doors to the hotel rooms where the deaths occurred were open or had been opened during the fire. There were no fatalities in rooms where the door had been kept closed (anon, 1982). This suggests that internal rather than external fire spread was the main reason for the deaths.

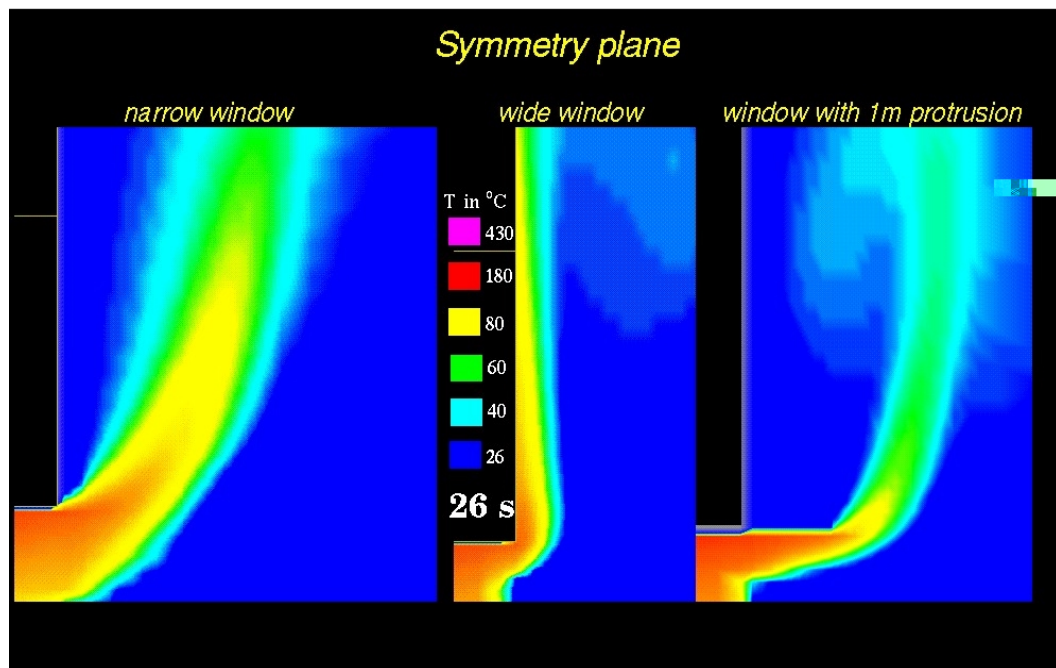
Galea et al (1996) used computational fluid dynamic (CFD) techniques in the analysis of fire plumes emerging from windows. They examined three window configurations; narrow, wide and wide with a 1 m deep external protrusion (apron). Figure 11 shows the results of the simulations with the plume being detached from the external wall for the narrow window, and attached for the wide window.

Figure 11: University of Greenwich simulation of window plumes (source: UoG, 1999)
